2016/17 Dry Run Creek Geomorphological Watershed Assessment

University of Northern Iowa
Department of Earth and Environmental Sciences

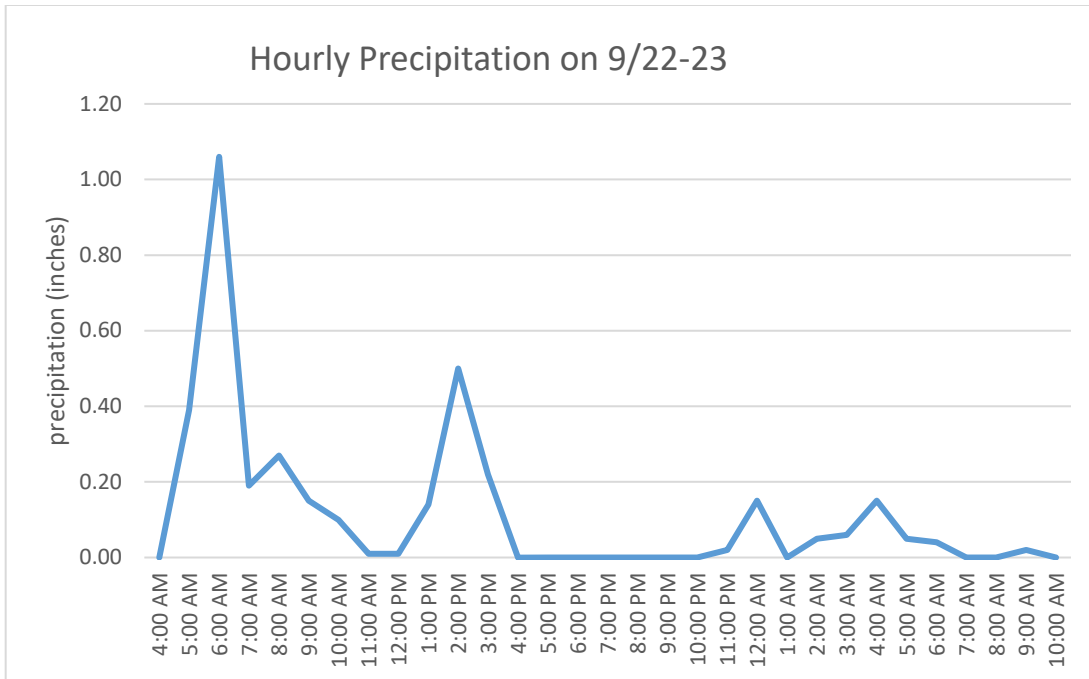
Figure 2. Hourly precipitation on Dry Run Creek, UNI's Campus, Sept. 22-23, 2016. Site 7, Dr. Mohammad Iqbal's (UNI) well site (<http://www.uni.edu/hydrology/>)

DRC drains an area of 15220 acres, with a topographic highpoint of 1025 and a low point where it discharges into the Cedar River of 845 feet. For one inch of precipitation, a percentage of 663 million gallons of water is added to the stream load of DRC for a certain duration of time. Exact percentage of precipitation that reaches DRC is not possible to calculate, but the effect a precipitation event has on the stream depth can help illustrate the increase in stream load (Figure 2 and 3).

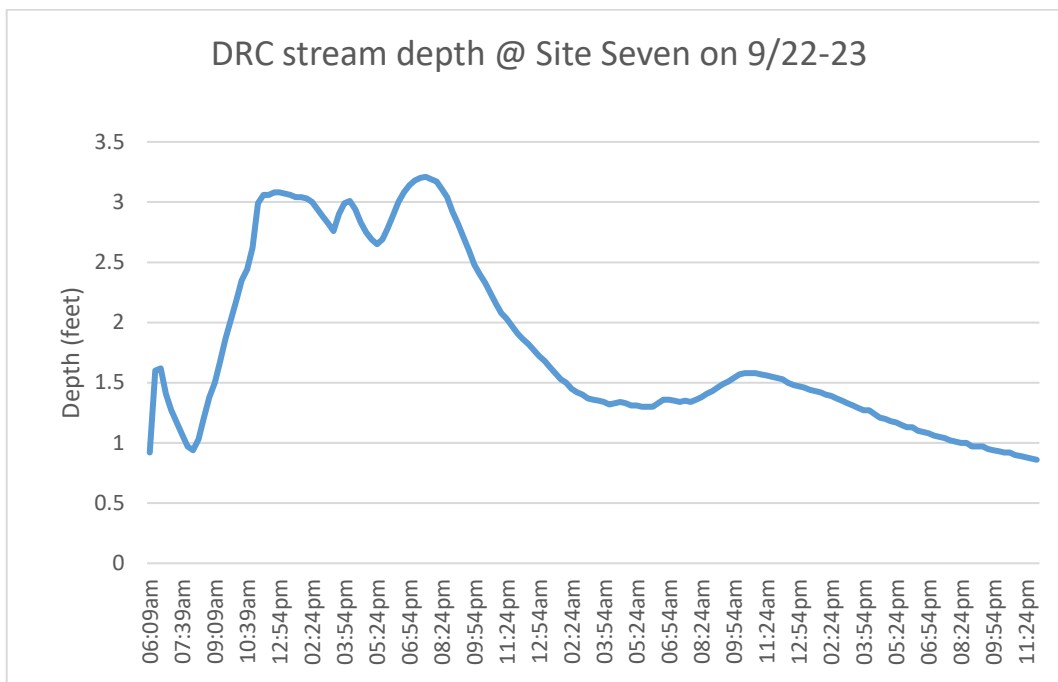
Figure 3. Hourly precipitation on Dry Run Creek, Site 7, illustrates the change in depth of DRC at site.

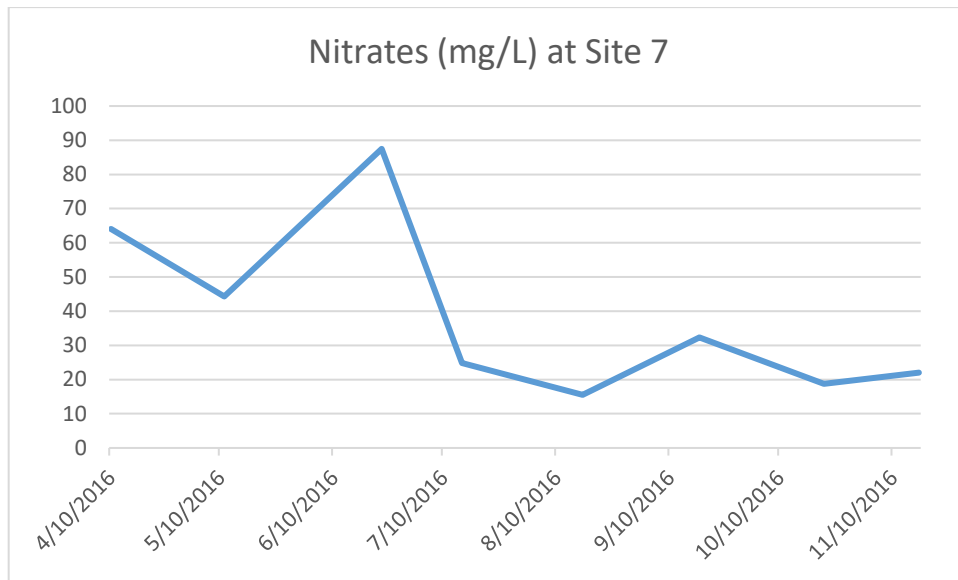
Figure 4. Site 7 Nitrate levels, Dr. Iqbal's well site also records data for other contaminants (e.g. E.coli)

Stream levels increase as rains come in April and throughout the summer months and taper off during the drier months of September through November. Though December, January, and February are the driest months (averaging an inch each), the stream is shallow enough that most if not the entire stream is frozen. Therefore, precipitation that does fall (in the form of snow) does not noticeably affect discharge, or erosion until spring thaw occurs. As urbanization increases and infiltration rates decrease, DRC's length and discharge continue to increase as the stability of the system continues to decrease. Simply stated, the DRC water resource has deteriorated as the urban area has grown. In addition, in-stream habitat and riparian zones that once helped filter the watershed have slowly been reduced over the last decades. With less filtration, larger precipitation events carry increasing amounts of sediment, nutrients, and synthetics (such as pesticides) into DRC (Figure 4).

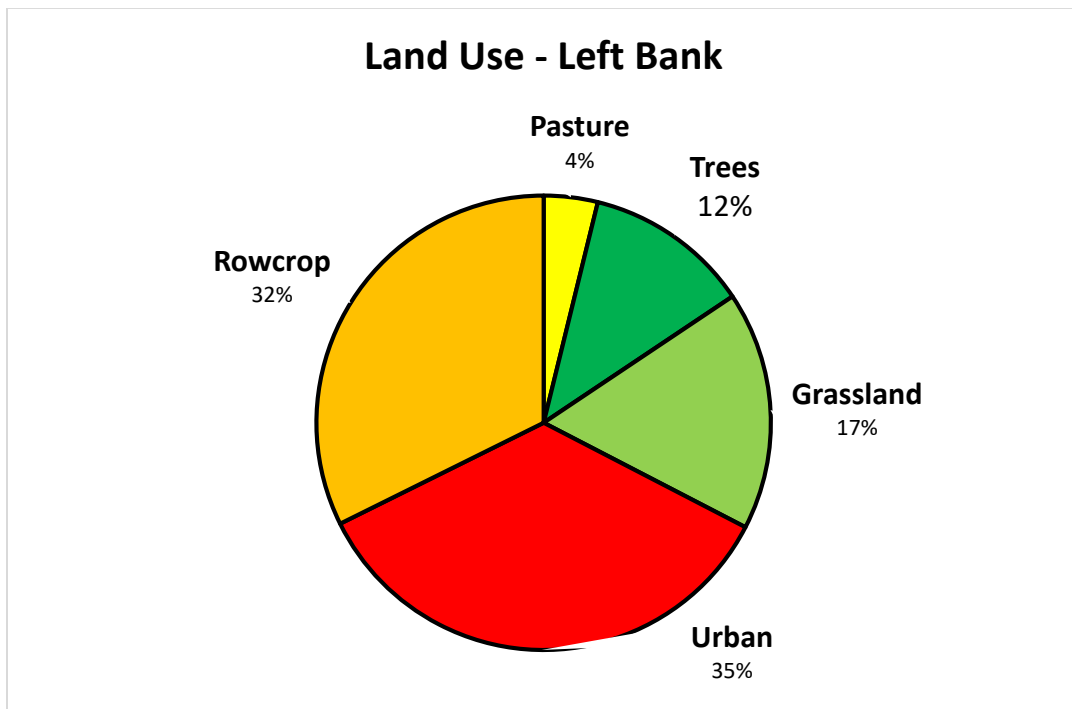
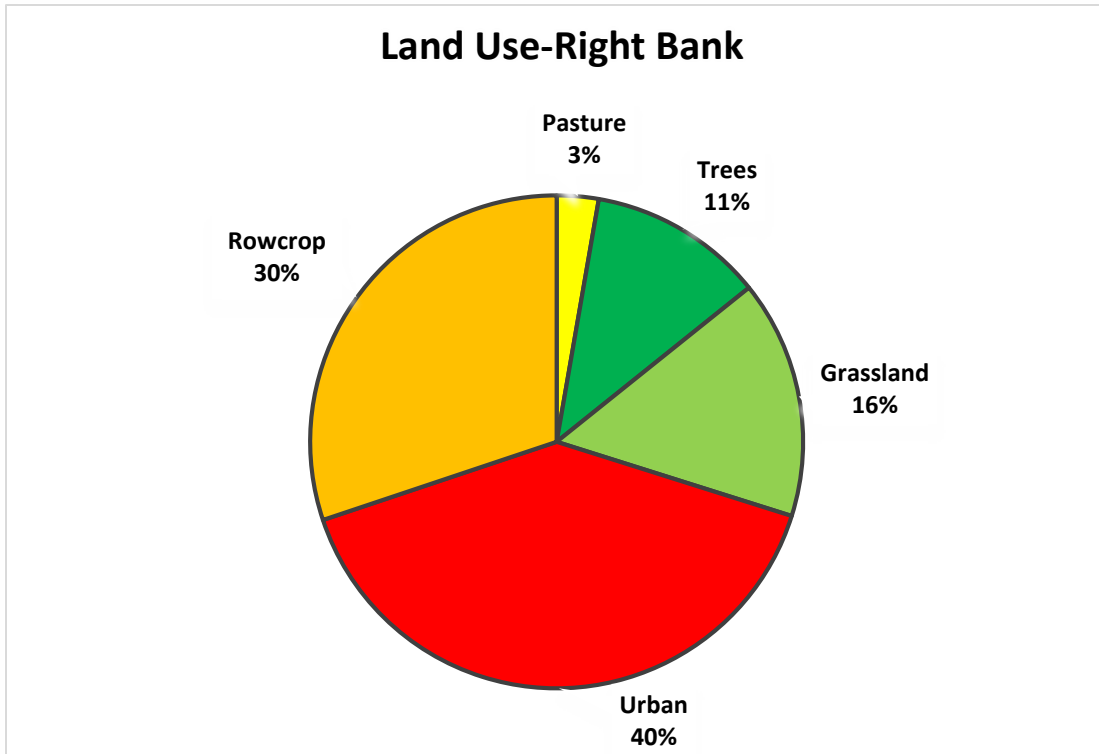
Figure 17. Land-use variability for DRC's left-bank.

Figure 18. Land-use variability for the right bank of DRC.

As time has progressed, the community of Cedar Falls has steadily grown, causing increasing portions of DRC to become further urbanized. As a result, land usage types surrounding the stream including agriculture, trees, grassland, and pasture have steadily declined and have been converted into urban landscapes. Currently, 37% of the Stream is surrounded by agriculture, and 35% of the stream is surrounded by urban areas. Grassland and trees represent 15% and 8%, respectively, and can often be found as a buffer between urban and agricultural landscapes. Pastures are least prevalent type, totaling only 5% (Figures 17, 18, 19 and 20).

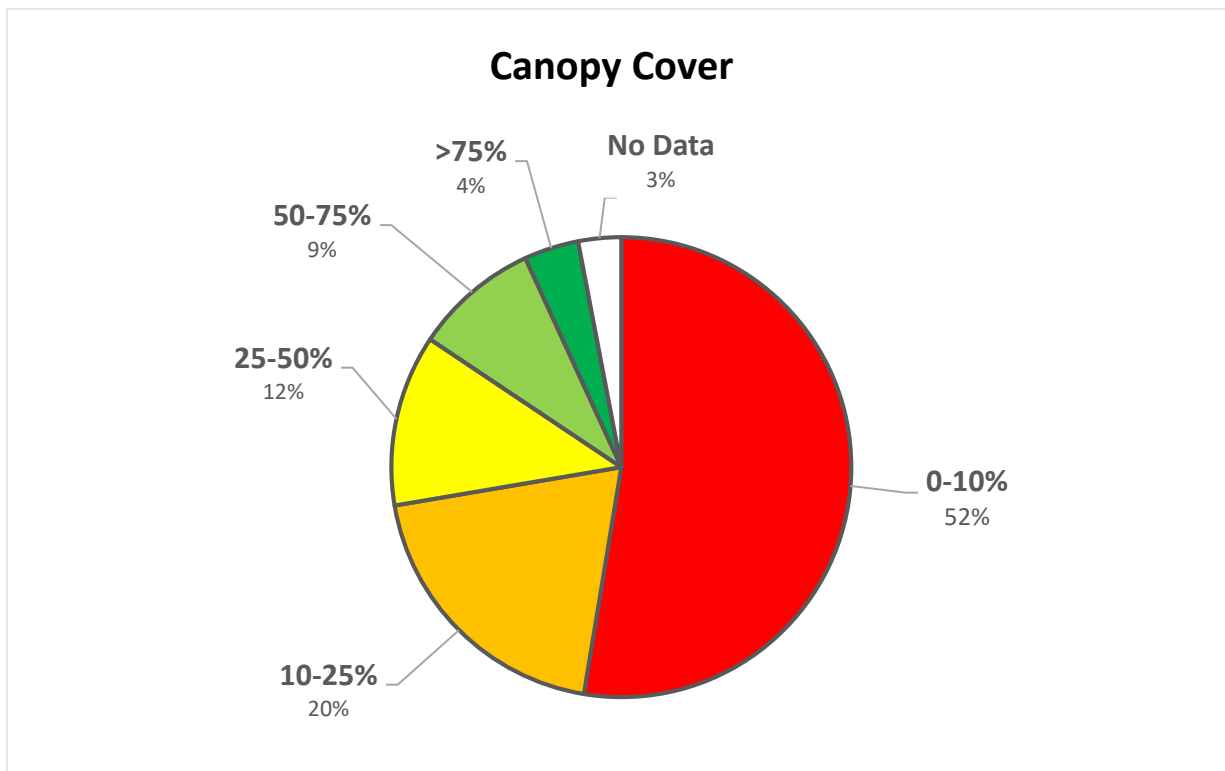
Figure 21. Variability of canopy cover along Dry Run Creek.

Figure 22. Canopy cover along Dry Run Creek, transposed onto a recent aerial photograph.

DRC is characterized by a lack of canopy cover along the majority of its course. 58% of the stream has 0-10% canopy cover, which predominantly represents areas of agriculture, but also includes various sections of the creek considered urban, grassland, and pasture. 21% of the stream has 10-25% canopy cover, but this percentage is heavily skewed towards 10%. 11% of the stream contains 25-50% canopy. Only 5% of the stream has 50-75% canopy cover, and 3% of the stream had greater than 75%. Most areas with greater than 25% canopy cover are found within city limits. The remaining 2% of areas sampled have no data on canopy cover because it was not estimated due to a lack of leaves because of the changing seasons (Figures 21 and 22).

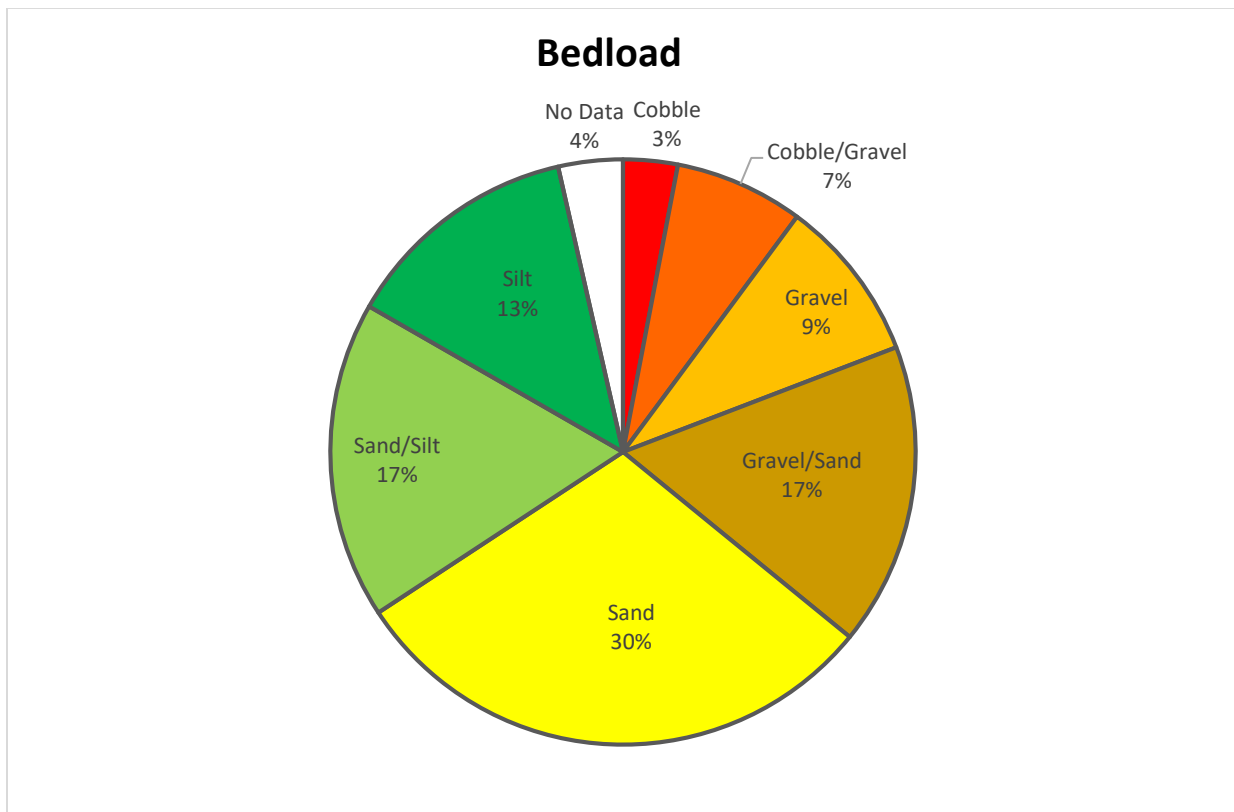
Figure 23. Substrate/bed load variability of Dry Run Creek.

DRC has a dominant substrate composed of a variety of sediment types due to Iowa's history of glacial activity, its location in an alluvial basin, rich soils, and high amount of human activity. Most commonly, the substrate of Dry Run creek is composed of sand. However, mixtures of sand and other sediments are also common. 36% of the substrate was described as sand, 19% was sand/silt, and 13% was sand/gravel. The largest portion of Dry Run Creek's substrate without sand is gravel at 11%. Silt was found in 10 % of the streams substrate, and cobble/ gravel composed a close 7%. A mere 1% of the streams substrate consisted of large cobble. The remaining 3 % of areas sampled have no data concerning substrate (Figure 23).

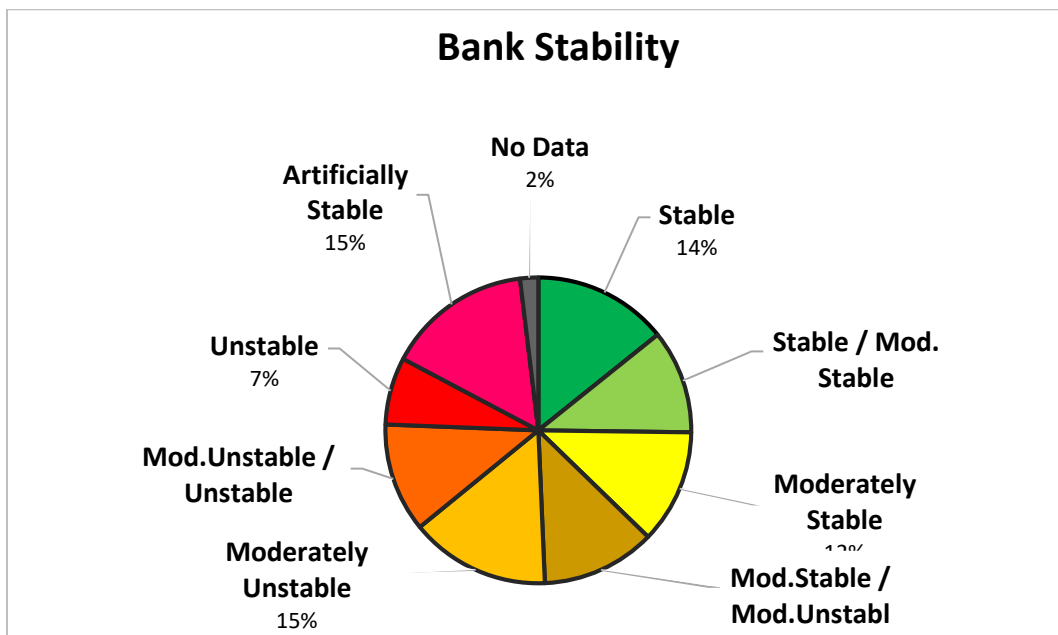
Bank Stability

Figure 24. Bank stability along Dry Run Creek.

Figure 25. Bank stability broken down into segments transposed onto a recent aerial photograph.

The bank stability of DRC varies greatly throughout its course. It changes drastically at times due to changes in land use & recent climate variability. Bank stability is measured on a scale from stable to unstable. Stable represents banks that are fully vegetated, have an absence of undercutting, gradual incline, and little to no visible soil. Unstable banks are characterized by non-vegetated banks, visible erosion, undercutting, and steep inclines. The most common bank stability class is moderately unstable, which represents 19% of the stream. It is followed by moderately stable/ moderately unstable banks at 14% and stable banks also at 14%. 13% of the stream is considered moderately stable, and 12% is considered moderately unstable / unstable. Stable / moderately stable banks compose 10% of the stream, and only 6% of the stream is considered as unstable. Currently, 8% of the stream is considered artificially stable, but this is likely to increase as Cedar Falls continues to grow as a community. The remaining 4% of areas sampled have no data concerning bank stability (Figures 24 & 25).

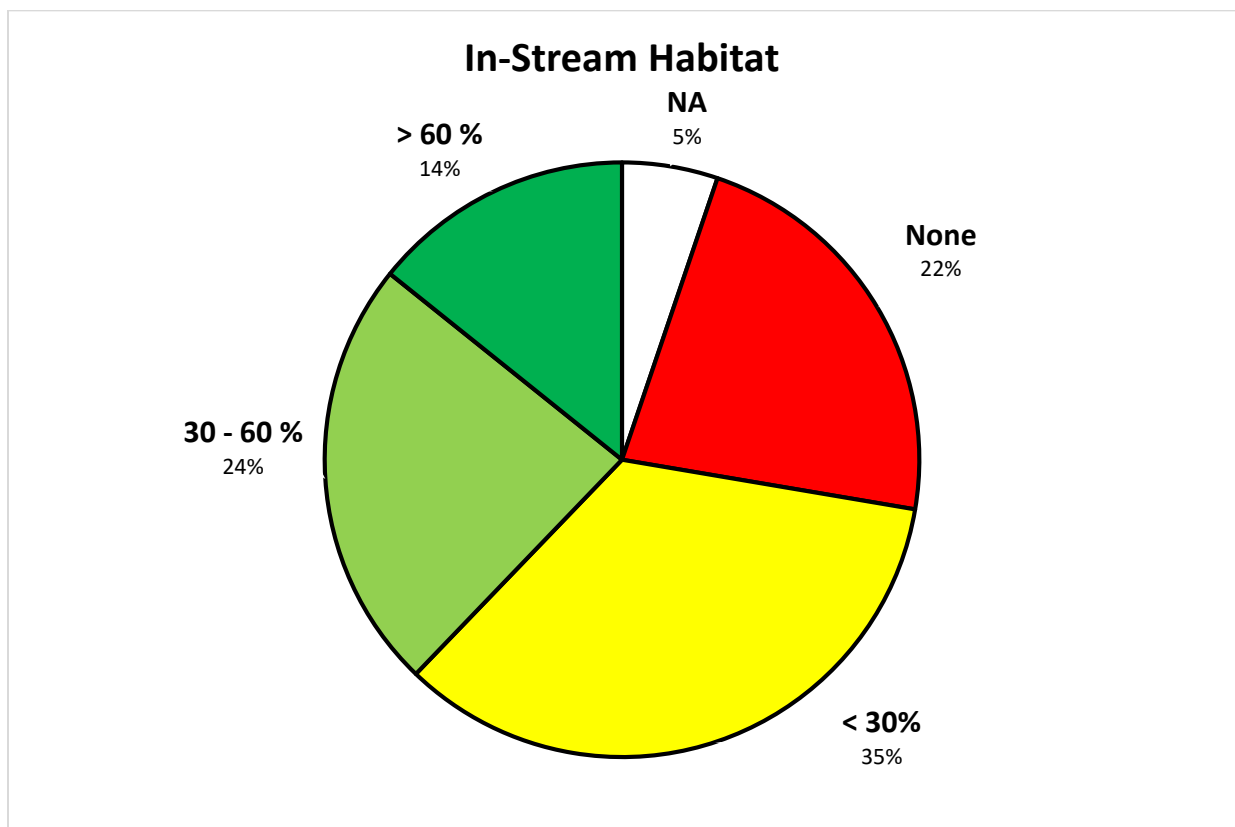
Figure 26. In-stream habitat percentages for Dry Run Creek.

Habitat within DRC is highly dependent upon human interaction, land use, and water quality, as well as many other factors. Habitat in this study is defined as the relative abundance of logs, root clusters, pools, and boulders present in the stream. 25% of the stream is considered to have no habitat because these components were absent within the creek. 41% of the stream was considered to have < 30% habitat because only small amounts boulders, logs, and root clusters were present. 22% of the stream contains 30-60% habitat, and 9% of the stream contained > 60% habitat. The remaining 3 % of areas sampled have no data concerning in-stream habitat (Figure 26).

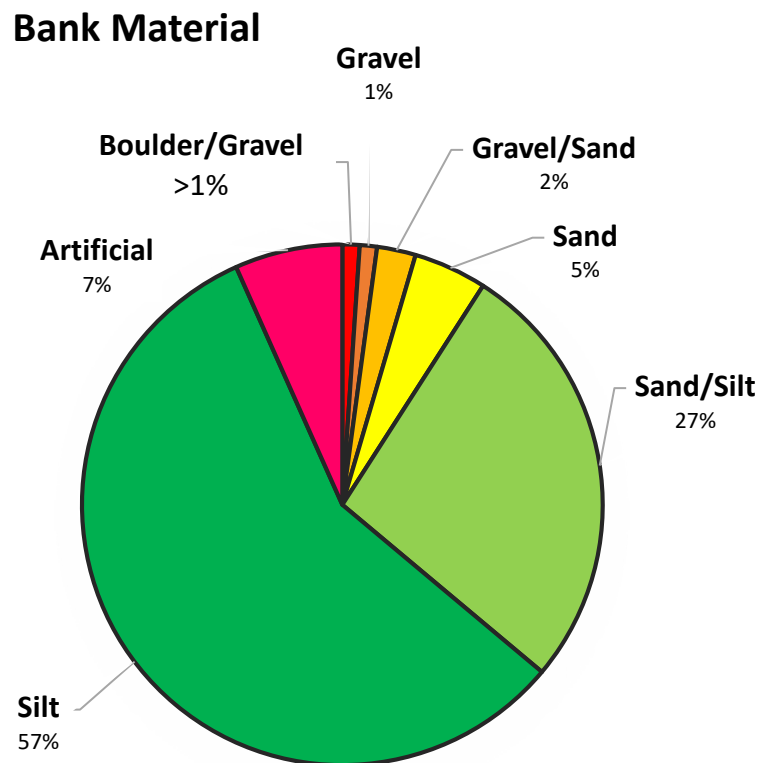
Figure 27. Bank material (sediment) for Dry Run Creek.

The banks of DRC are composed primarily of silt, but have many accessory sediments that compose them. 62% of all stream banks sampled were predominately silt in nature. 22% of stream banks were a sand/silt mixture, and 7% were only sand. A mere 3% of stream banks were a sand/ gravel mixture, and 1% was gravel. Less than 1% of stream banks were composed of boulders and geologic outcrops. The remaining 3 % of areas sampled have no data concerning bank material (Figure 27).

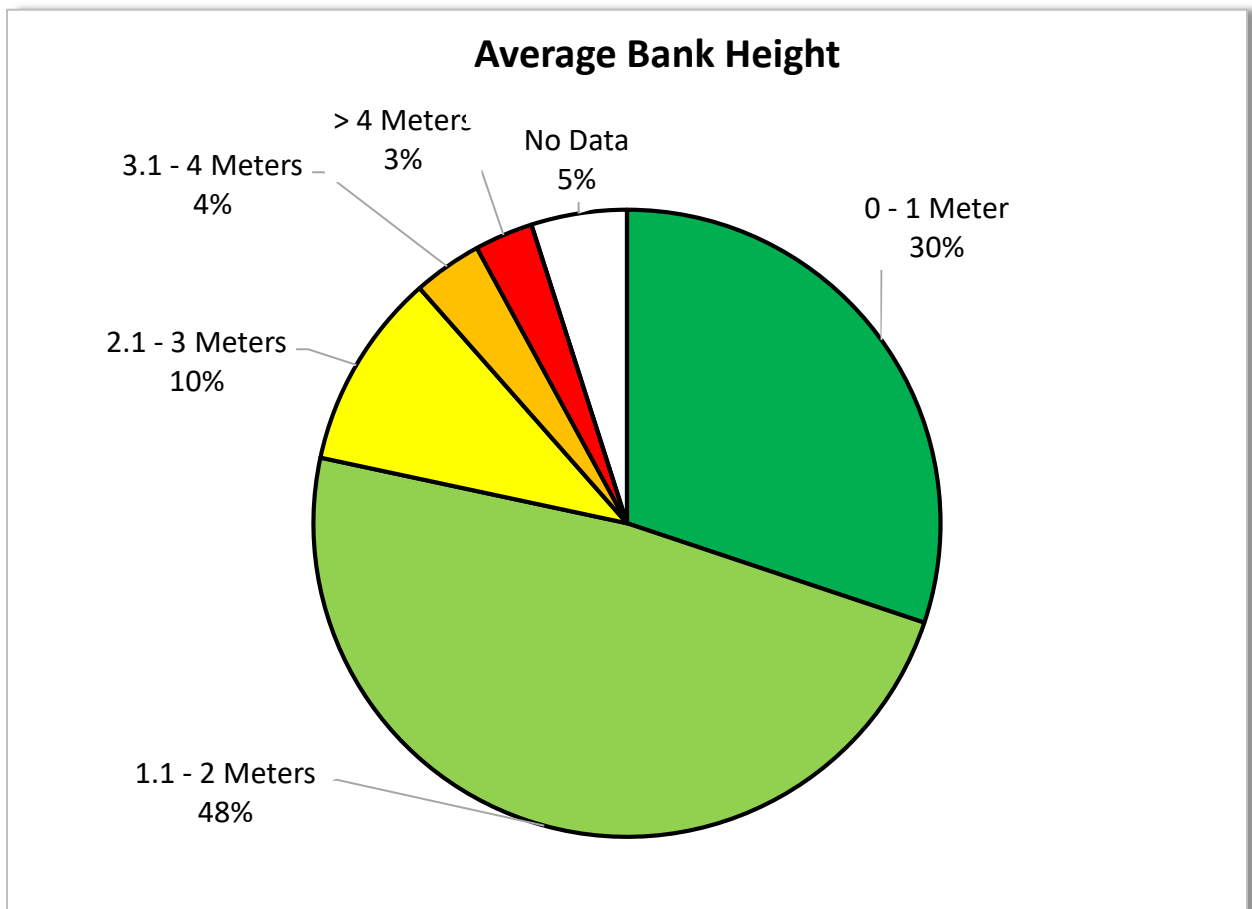
Figure 28. Average bank heights for Dry Run Creek.

Figure 29. Average bank heights broken down into segments transposed onto a recent aerial photograph.

Average Bank heights within Dry Run Creek depend heavily upon land use type. Agricultural areas tended to have shorter, more gradual banks, and urban areas had higher, and more steeply sloping banks. The predominate bank heights within DRC were between 1.1–2 meters and consisted of 42% of the stream. The next largest percentage of bank heights lied between 0 -1 meters and consisted of 37% of the stream. 8 % of banks ranged from 2.1-3 meters, and 3% ranged from 3.1– 4 meters. Another 3% was higher than 4 meters (Figures 28 and 29).

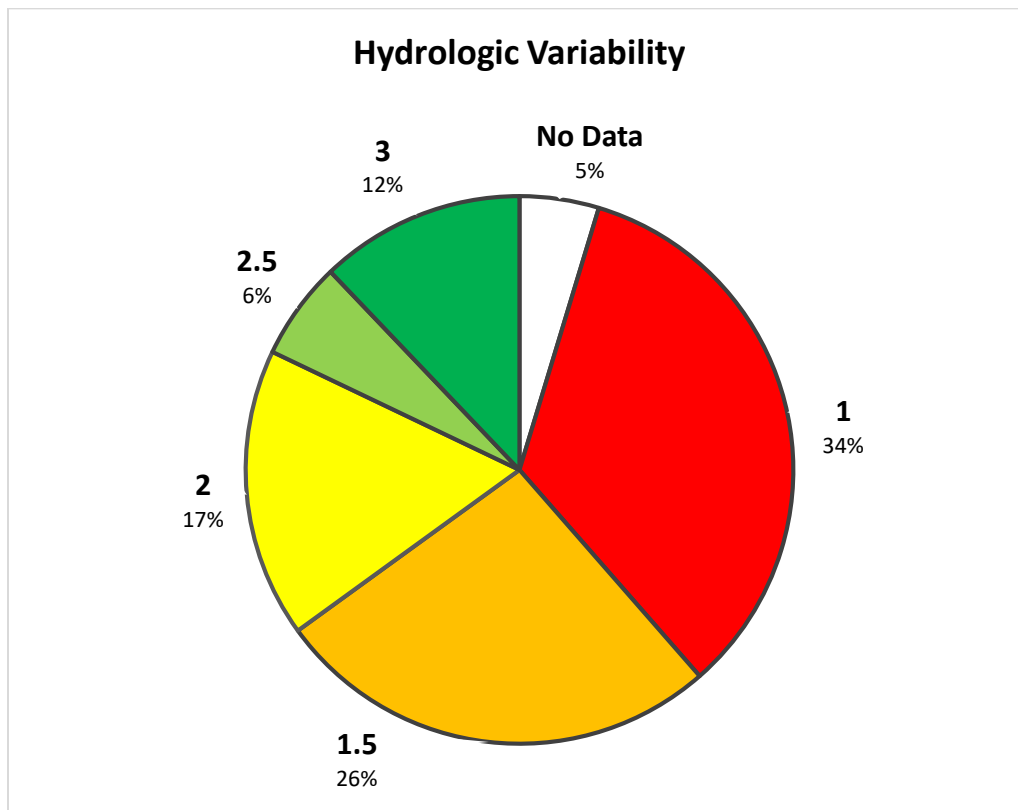
Figure 30. The 2016/17 hydraulic variability of DRC based on 365 observations.

Figure 31. Map characterizing the hydraulic variability of Dry Run Creek.

Natural variability/changes (width, depth/pools, course of direction) within a stream may be used as one mechanism to interpret overall health. The major ratings for variability are: 1 (red), Uniform depth and width, 2 (yellow) somewhat variable and 3 (dark green) natural pool and riffles. The 2016/17 observations identified 60% of the stream at 1 to 1.5, or having poor variability. Eighteen percent of the stream was characterized as having good natural pool and riffle variability (Figure 30). Poor variability rates are commonly associated with agricultural and urban landscape modifications, at times either completely rerouting channel location and/or binding the channel within concrete (Figure 31). Good or natural stream variability sections are most common adjacent urban/forested landscapes (e.g. UNI's campus and biological preserve).

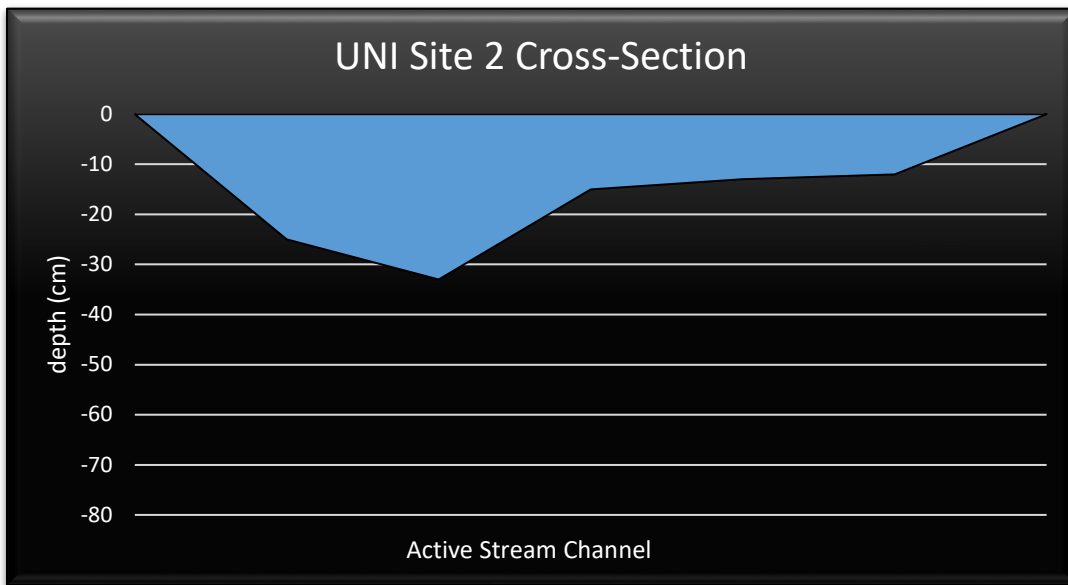
Figure 36. UNI site two-stream geometry.

Three UNI Campus Sites along Dry Run Creek were surveyed for their cross-section geometries (Figure 34). These data provide support to the morphometric understanding of Dry Run Creek. Three stream profile cross-section exhibit diverse characteristics through a relatively short distance across campus. The depth range was 20 to 55 cm (Figures 35, 36 and 37). The width range was approximately 1020 to 580 cm (Figure 38). Averages (depth and bank height) and R^2 values were calculated for these stream geometries (Figures 39 and 40).

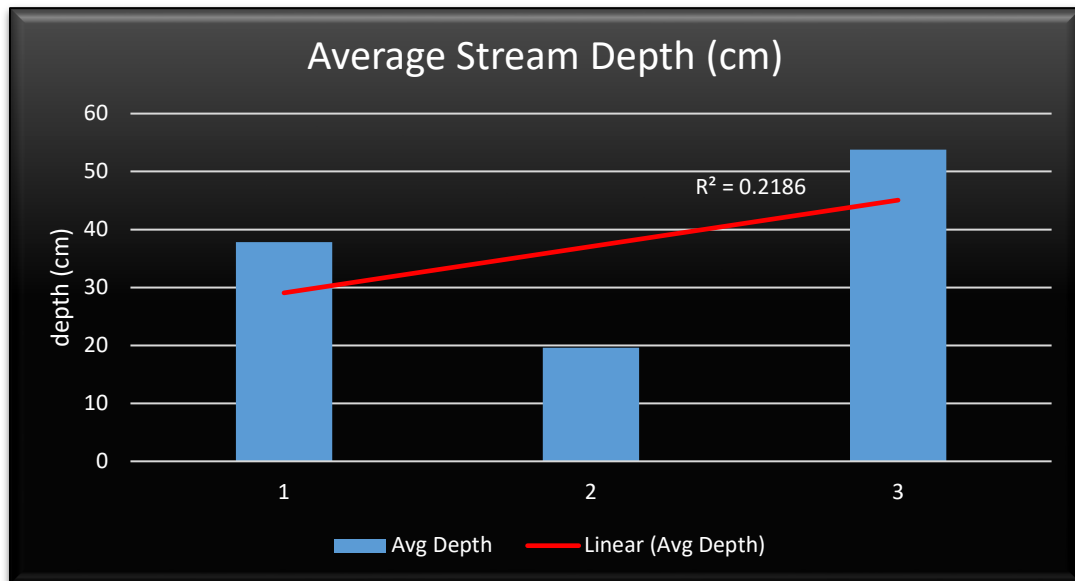
Figure 40. Average stream depths (Site 1, 2 and 3) with R^2 value.

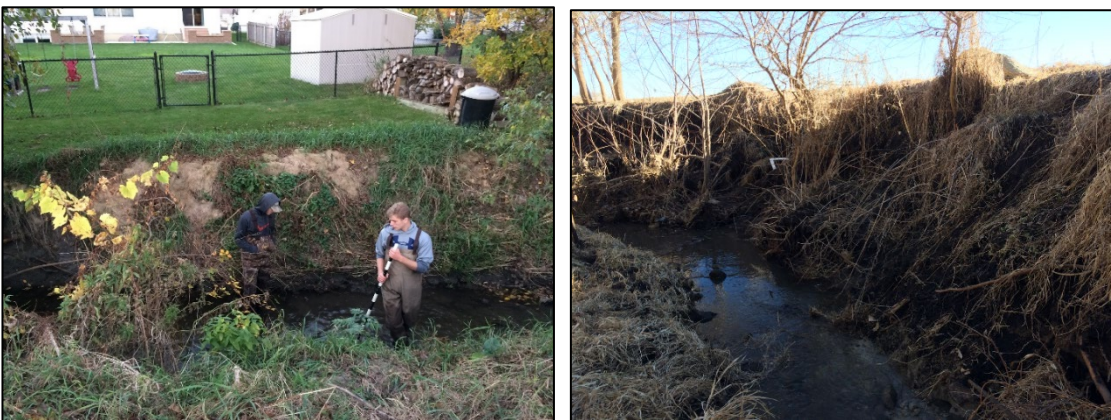
Figure 43. Photographs exhibiting urban (left) and agricultural (right) stream health. Unstable conditions are dominant throughout the creek; these images show erosive/cut banks and row crops or a mowed and maintained yards come directly up to the stream. This amount of erosion on the banks throughout the stream promotes increased runoff leading to more erosion.

Agricultural and urban land coming directly up to the stream banks leaves little to no buffer zone capable of decreasing the velocity of water and/or contaminants moving from the land toward the stream (Figure 43). In order to improve water quality, in-stream habitat, and/or bank stability, the Dry Run Creek Improvement Project should continue encouraging remediation practices especially in areas exhibiting these high instability. Point source runoff from agricultural and urban tiling was identified throughout the watershed (Figure 44).

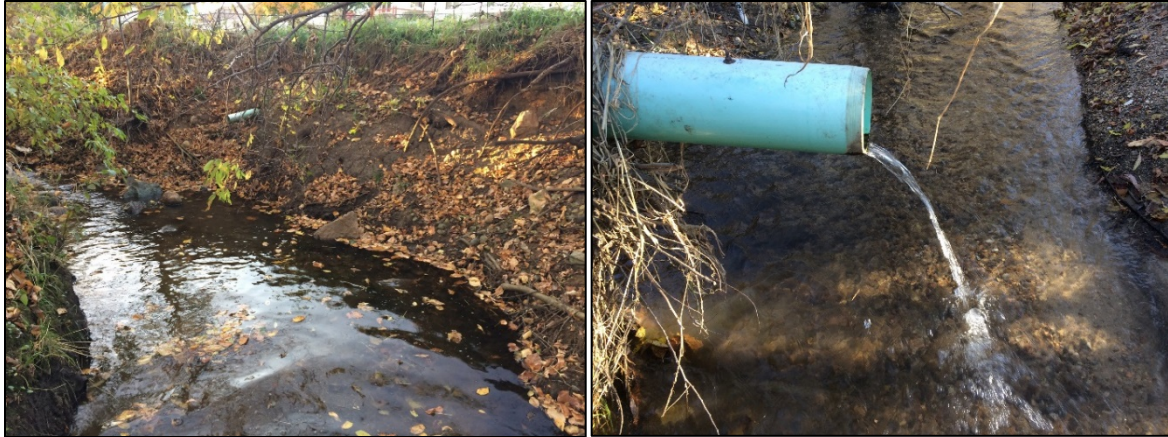
Figure 44. The images above provide examples of what this point source runoff looks like in the field. The image on the left show point source runoff in an urban area, while the image on the right shows a farm tile entering the stream

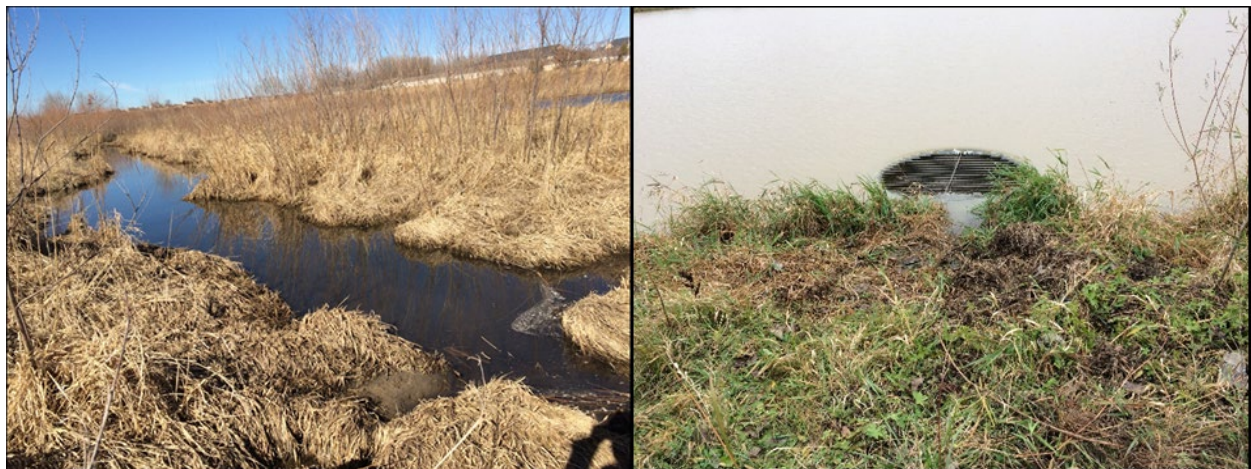
Figure 45. The image on the right is an example of a retention pond constructed in a new housing development in Cedar Falls. Retention ponds can be used to slow the rate of flow and artificially managing water, although the example on the right has a drain where the water would go down into the sewer system instead of flowing naturally into the stream or being infiltrated into the ground. The photograph on the left provides an example of a relatively successful restoration project; Located on UNI's campus, this wetland project is beginning to manage water effectively while providing positive influences on the Dry Run Creek and its overall health.

Retention ponds and constructed wetlands can be positive examples of remediation (Figure 45). With a growing number of urban development's proper retention pond education and construction needs to be implemented to develop the most positive impact on the neighborhood as well as the streams health.

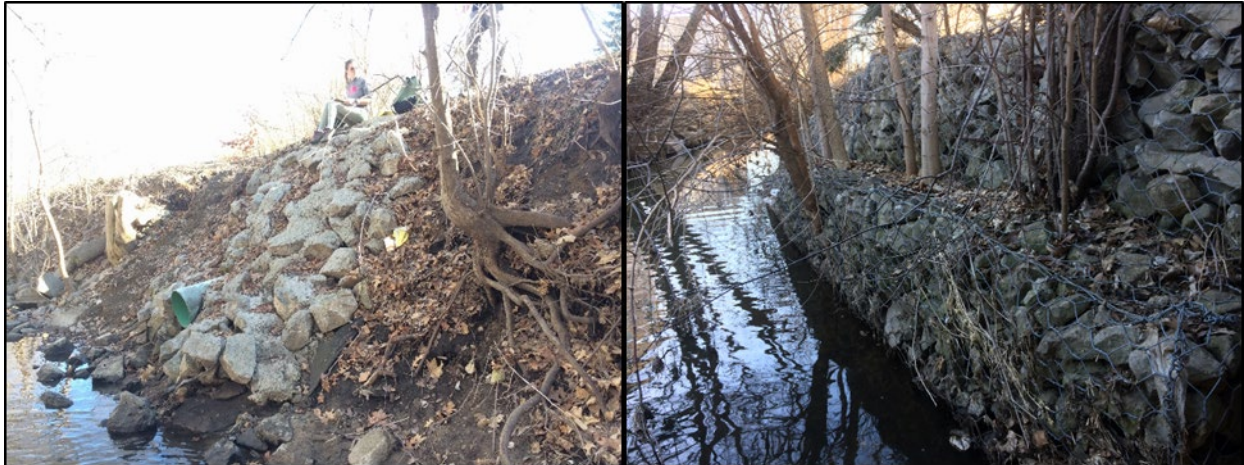
Figure 46. The image on the left shows a poor example of bank stabilization, where debris and cement was slopped into the stream and down the bank. Concrete is not a good way to stabilize it gives no movement for the stream and will speed up the waters movement causing more erosion to occur. The image on the left is between UNI's campus and College Street where apartments are being built, these apartments are right on the streams edge and rip rap was implemented to control bank erosion throughout this area. This kind of stabilization will help to prevent erosion, but not allow the steam to move at all.

Artificial stabilization in urbanized areas commonly occurs along Dry Run Creek through Cedar Falls. Rip rap is used mostly throughout these sections. Some of these stabilization projects are effective; others make stabilization worse (Figure 46).
